**Indoor Air Quality Assessment  
MCCT  
Grand Jury Room and The Grand Jury Administration Office (Floor 3)  
40 Thorndike Street  
Cambridge, Massachusetts  
August 1999**

**Cambridge Superior Court  
Grand Jury Room  
Middlesex County Courthouse  
3<sup>rd</sup> Floor  
40 Thorndike Street  
Cambridge, MA**

Prepared by:  
Massachusetts Department of Public Health  
Bureau of Environmental Health Assessment  
August, 1999

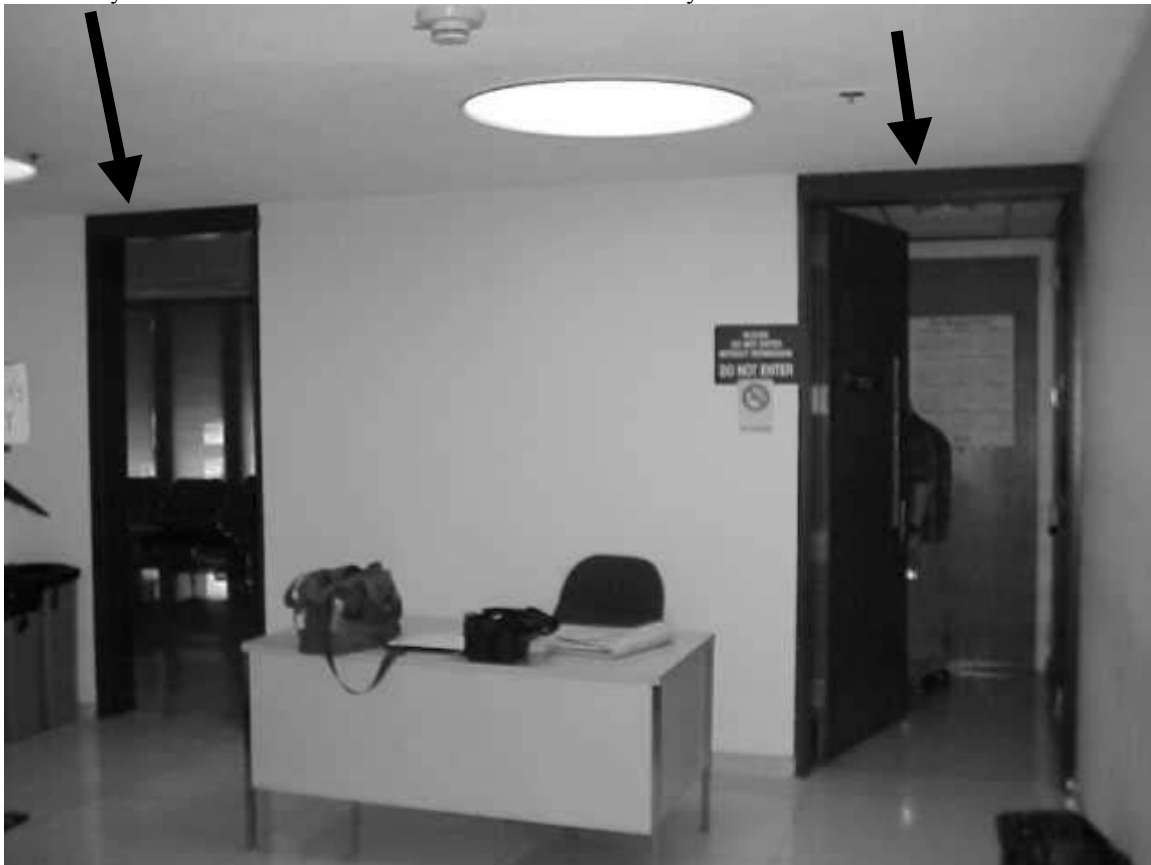
**Picture 1**

The grand jury area is located on the third floor of a twenty-three story multi-level building. This evaluation focused on the Grand Jury Room 3-59 and the grand Jury Administration Office 3-59 (see Picture 1). Also included in this evaluation were the jury dining rooms on the second floor. The building does not have openable windows. The windows are single paned and have tinting to reduce solar glare (NIOSH, 1990).

**Grand Jury Area**

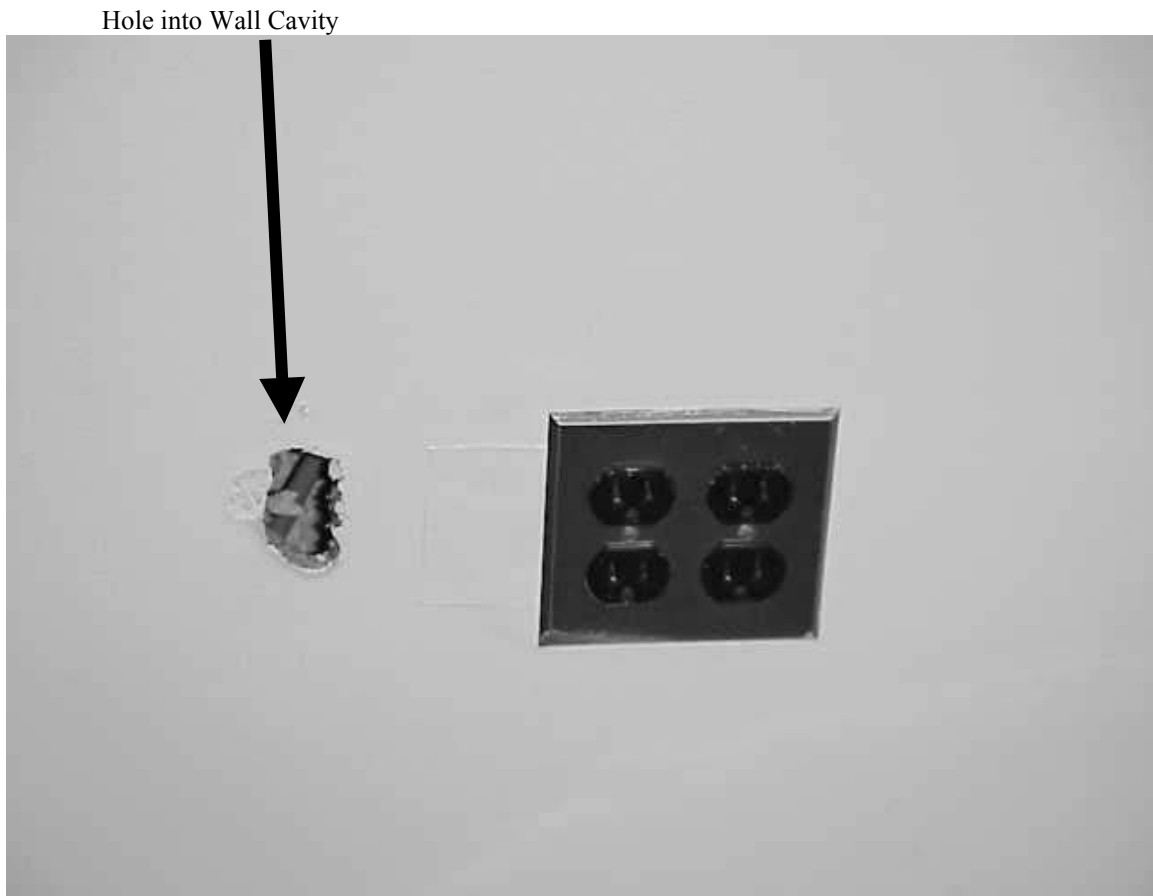
**Picture 2**

On June 18, 1999, a varnish like odor was detected within the Grand Jury Room 3-55. This odor was traced to a hole in the interior wall between this room's windows (see Picture 2). Carbon monoxide and hydrogen sulfide were not detected in any of the indoor/outdoor samples collected during this assessment. A strong draft of air was noted moving from the wall cavity into the Grand Jury Room through this hole. A similar odor was noted in the adjacent Grand Jury Administration Office, 3-59. In no other area within the grand jury area was an odor detected. Court officials reported that ceiling tiles in the second floor cafeteria and jury dining rooms were painted with an acoustic paint. Upon discovering this fact, the jury dining rooms that are directly beneath the grand jury room were examined to ascertain whether off gassing constituents of the paint was the source of this odor. Both the jury dining rooms and hallway had painted ceiling tiles (see Pictures 3 & 4). No odors were noted on the second floor. Court officials were asked to temporarily seal the hole in the Grand Jury Room with duct tape to prevent further penetration of the odor into this area.

dining rooms. Upon entering the Grand Jury Room, no odor was detected. The duct tape seal on the wall cavity hole was removed and the interior of this cavity was examined with a borescope. The wall cavity appears to have space between the exterior wall and the floor decking. This space can serve as a pathway between the third floor and the second floor ceiling plenum. VOC air samples were taken within the wall cavity by inserting the PID probe into the wall cavity. While VOC levels within the room were found at background (outdoor) air levels [0.6 parts per million (ppm)], air samples taken from within the wall cavity were measured at 1.5 ppm, which indicates an off gassing material within this space. All TVOC measurements throughout the Grand Jury level were at outdoor background level. The hole was resealed with duct tape.

**Hole in Wall of Grand Jury Room**

1. Seal all wall holes permanently with spackle. Seal all wall seams around the induction units with an appropriate seam sealing compound.

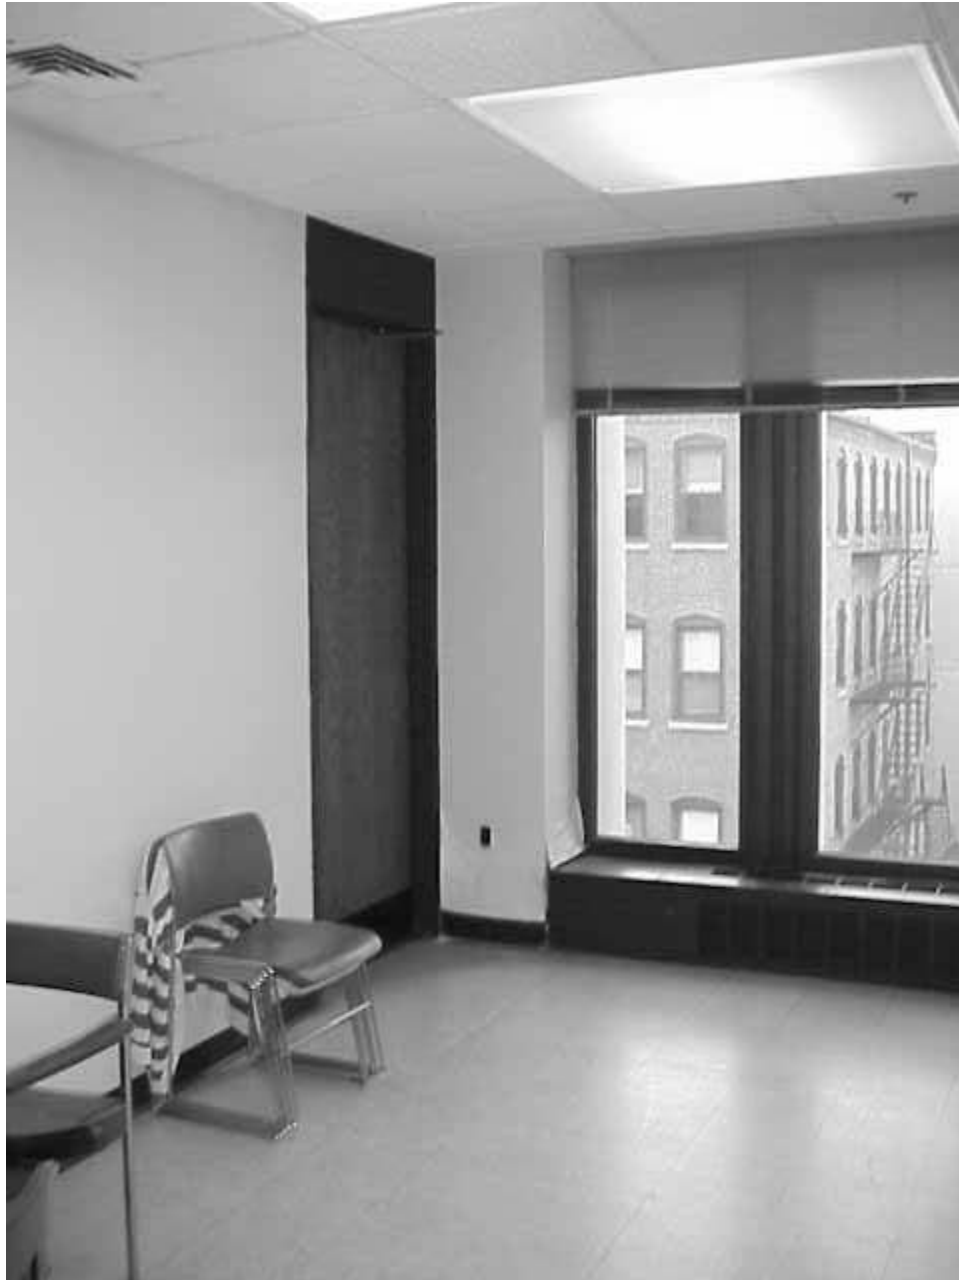
**Picture 3**

Moisture content of ceiling tiles in the jury dining rooms were measured to ascertain whether moistened ceiling tiles were painted, resulting in an extended drying time. Ceiling tiles immediately adjacent to fresh air diffusers and exhaust vents as well as randomly chosen ceiling tiles not adjacent to ventilation equipment were evaluated. Randomly selected ceiling tiles not adjacent to ventilation system equipment had a moisture content of 0 %. Ceiling tiles immediately adjacent to and within approximately three feet of the air diffusing unit and the exhaust unit of the dining room, had a moisture content between 8-9.5% (see Picture 5). This indicates that there is trapped moisture within these ceiling tiles.

**Jury Dining Room below Grand Jury Administrative  
Office with painted Ceiling Tiles**

2. As a temporary measure to prevent TVOC movement into the grand jury administration office seal electrical outlets to serve as a TVOC barrier.
3. Once the grand jury area is sealed, employ exhaust ventilation to dry the ceiling tiles. Since the building does not have openable windows, exhaust ventilation has to be directed into the interior of the building. If this is done, exhaust ventilation should only be done after business hours, preferably on the weekend when there are minimal amounts of employees in the building. Please note that exhaust ventilation may not succeed in reducing odors, since moisture is sealed within the tiles.
4. If exhaust ventilation is not practical or does not succeed, consider replacing the ceiling tiles in two layers around each ceiling mounted vent (see Picture 8).

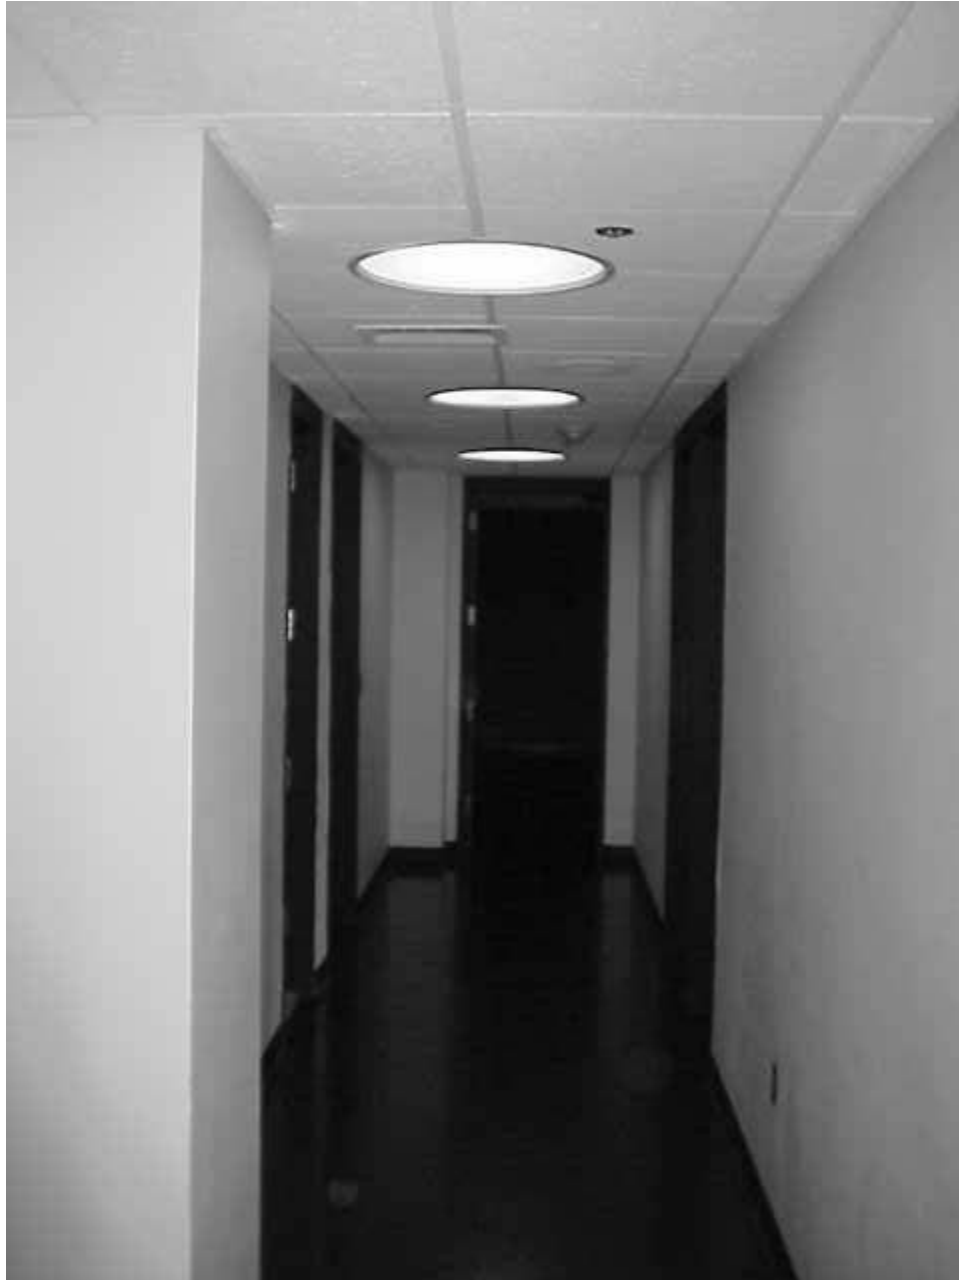
**Picture 4**

**Jury Dining Room Hallway with Painted Ceiling Tiles**

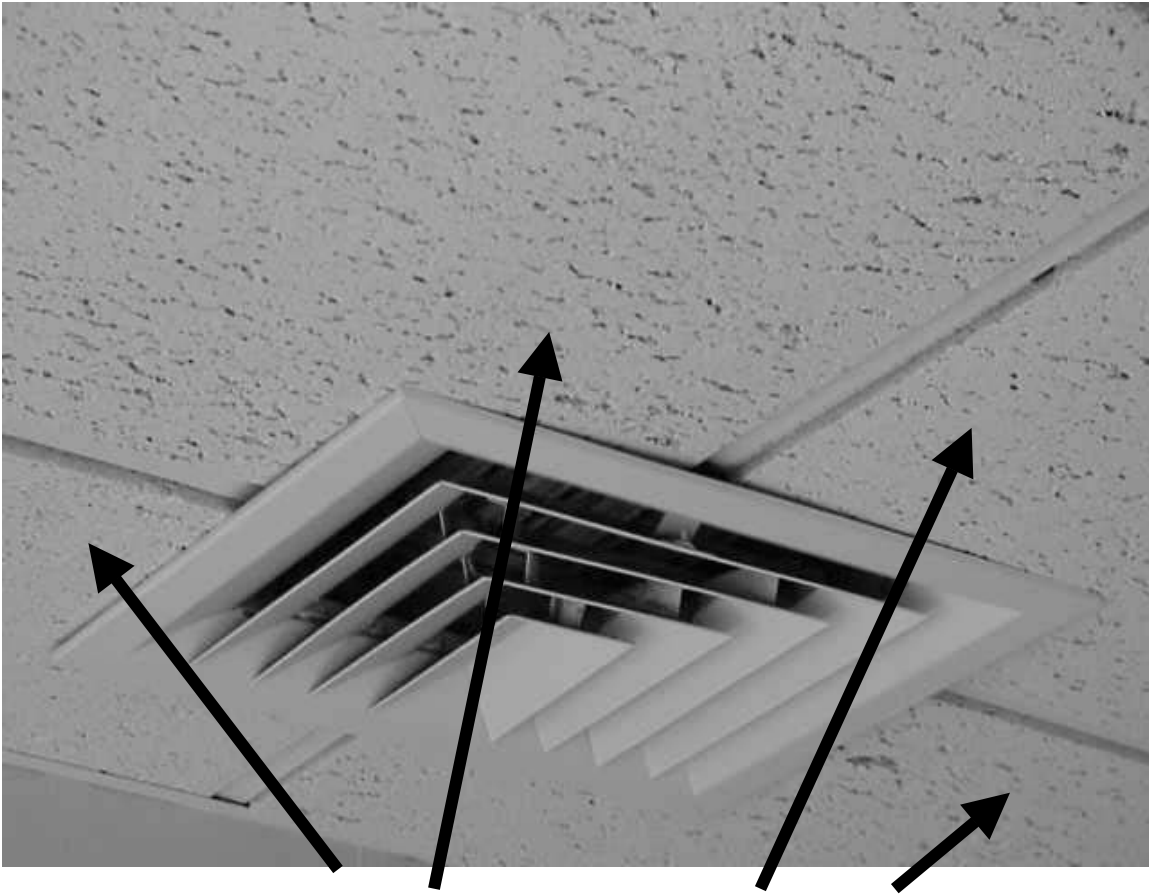
**Picture 5**

As noted by the low carbon dioxide levels measured during this and previous assessments in other parts of the building (MDPH, 1999), the heating, ventilation and air-conditioning system introduces a large amount of fresh air into the building. It is believed that these ceiling tiles were painted during a time of high relative outdoor humidity. During hot, humid days, the intake of large amounts of fresh air also

introduces water vapor into the HVAC system. Materials nearest ventilation equipment, such as ceiling tiles, can become coated with a layer of moisture.

If this moisture is covered with paint, the ceiling tile does not have a means to allow for moisture to evaporate. In addition, with moisture sealed against the tile, paint constituents would not dry as rapidly as if it were applied to a dry surface. The exterior surface of the paint will dry, leaving the surface of the paint in contact with the ceiling tile wet. This condition can lead to extended drying times, which can lead to off gassing of VOCs from moistened ceiling tiles. Since the ceiling tile system in the jury dining rooms is closest in distance to the grand jury area and, an air movement pathway exists between the second and third floor, it is likely that TVOCs from off gassing paint had entered the grand jury room through the wall hole and into the grand jury office through electrical outlet holes or wall seams around the window induction unit.

**Example of Moistened Ceiling Tiles around Air  
Diffuser Sampled for Water Content**

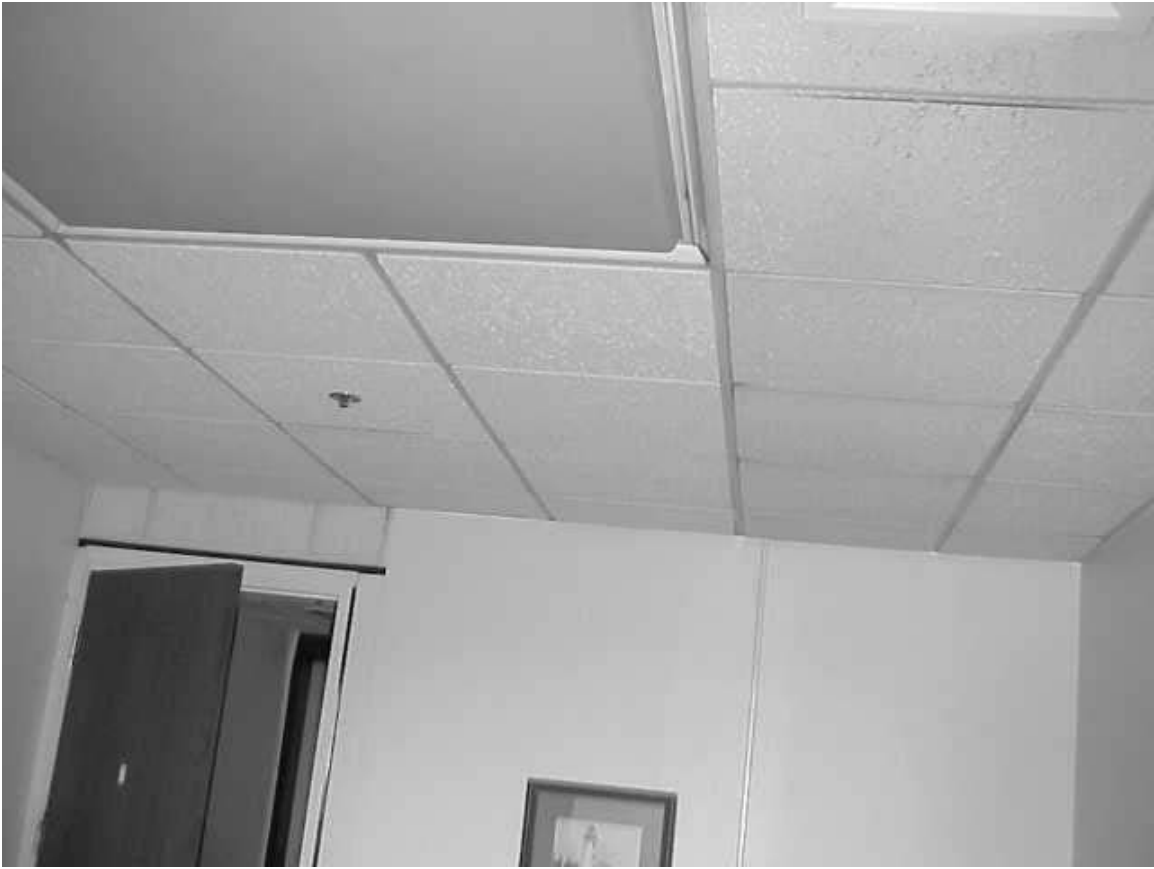
**Picture 6**

Enhancing the draw of air from the wall cavity in the Grand Jury Administrative Office is the configuration of the induction unit, ceiling-mounted fresh air diffusers and exhaust vent. At some previous time, a wall was constructed which divides the induction unit and the ceiling-mounted fresh air diffuser from the exhaust vent. With the door closed, no exhaust ventilation exists in this office (see Pictures 6 & 7). Without exhaust ventilation with the door closed, TVOC odors can build up in this space.

**Ceiling without Exhaust Vent in the Grand Jury Administration Office**

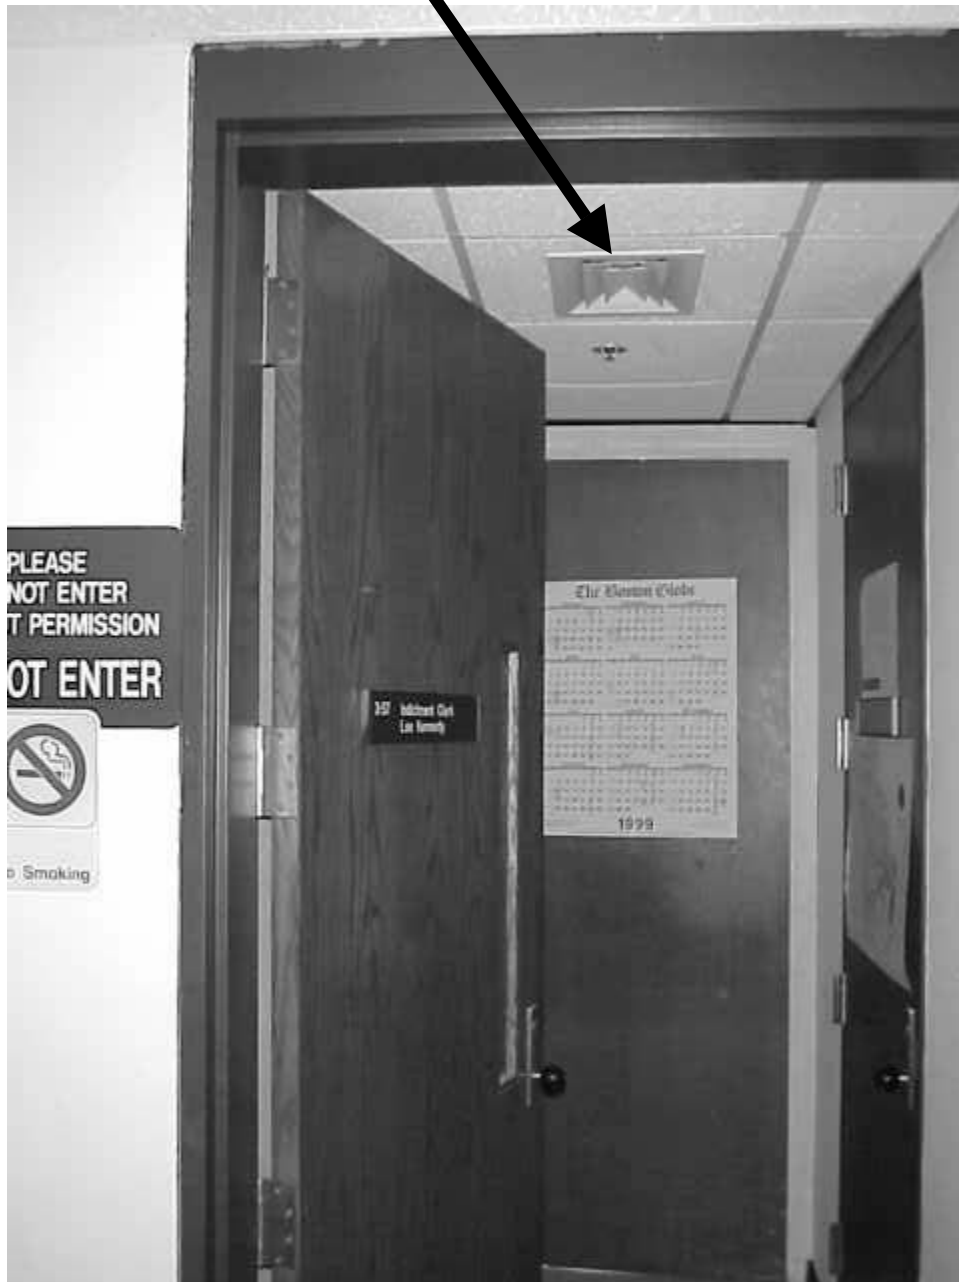
**Picture 7**

**Exhaust Vent Outside of the Grand Jury Administrative Office**

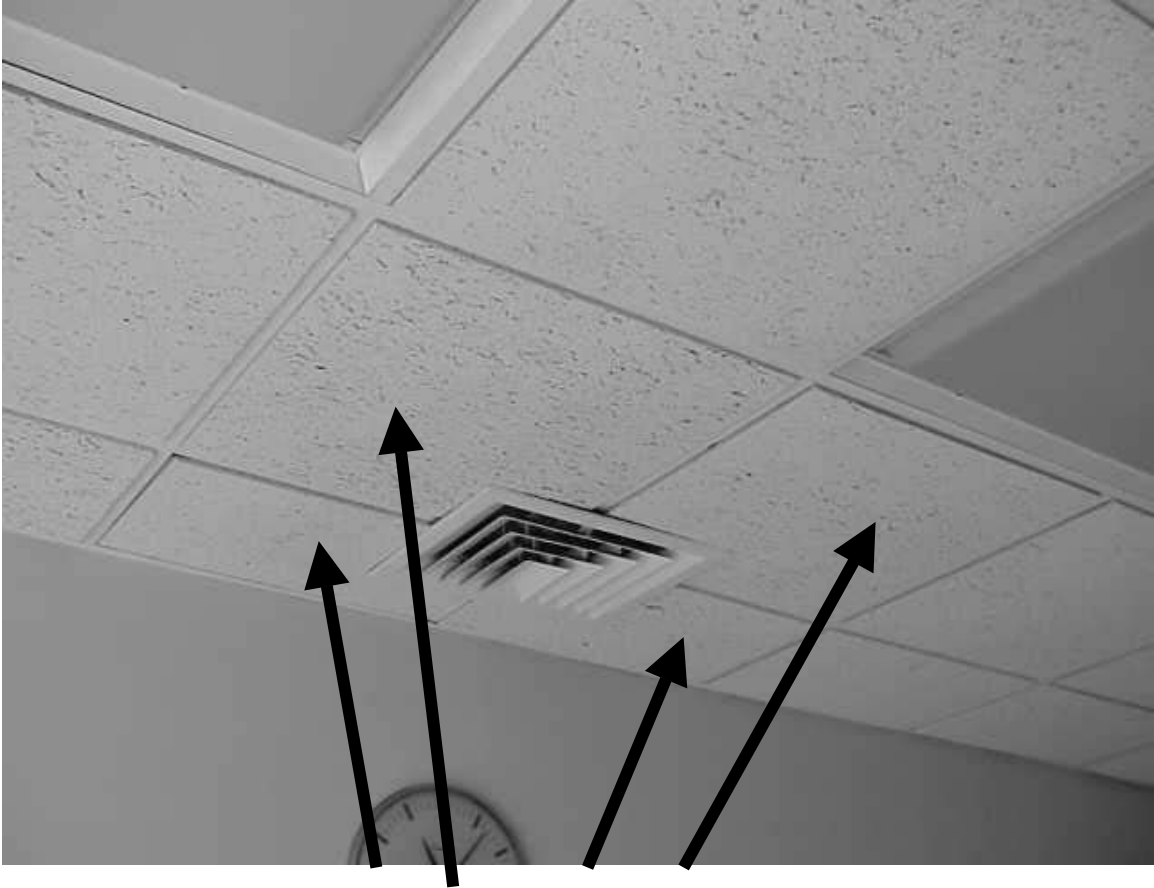
**Picture 8**

**Ceiling Tiles Recommended for Removal if this Option is Chosen**
